Results of Dry Weather Water Quality Sampling around the Headwaters of Arboretum Creek in September, 2018:

FOAC Technical Memorandum #2¹

— Dave Galvin 12/29/2018

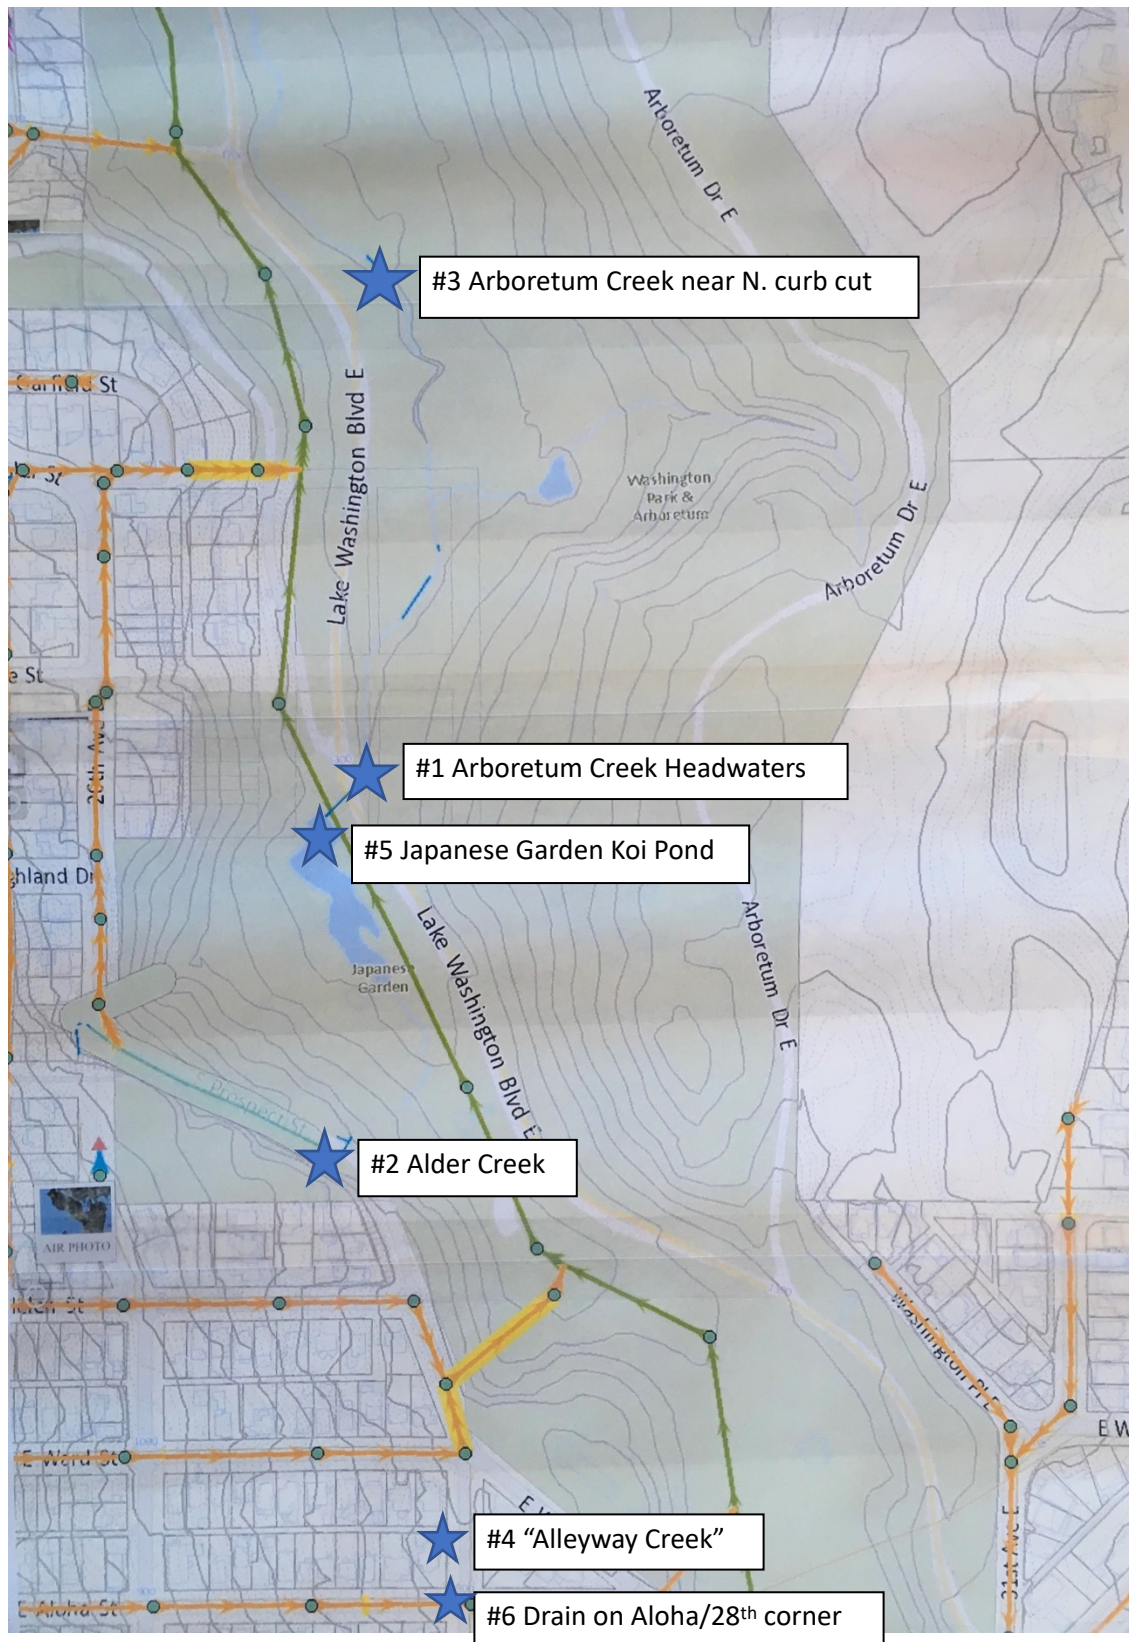
Figure 1. Map locating six sampling sites in the “headwaters” area of Arboretum Creek.

Figure 1 shows the locations of these six samples. Our reasons for choosing these sites are as follows:
